1953 BN1 (Healey 100) restoration project – present state

Ed Driver

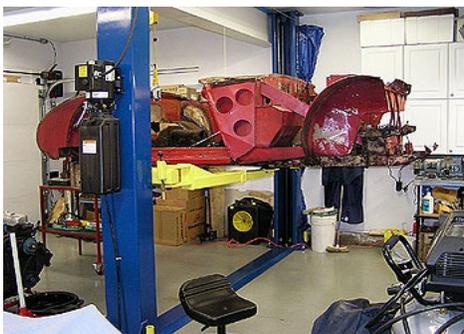
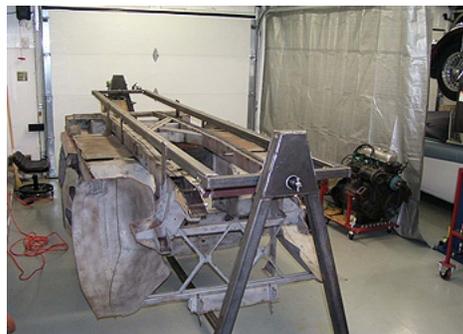
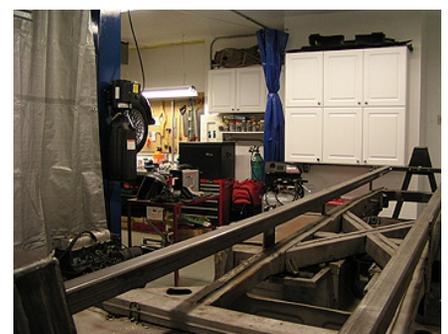
After attempting to patch the rusted out rails of the Healey chassis – a process known as chasing welds, the crossroad was reached. These chassis were original 14 gauge steel, two “D” pieces welded together. Well mine had evolved into 26 gauge thickness – the damaged lower front cross member and one side of the rear axle attachment site were entry sites for moisture. In addition it was evident that at one time the car was in a major collision, the front right chassis rail and the rear right of this rail were damaged. Surprisingly the diagonal measurements between the front and rear cross-members indicated a very square chassis. In addition to the rail rust, the rear wheels arches, the inner wings, the inner sills,

the outer sills, and portions of the A pillar, both foot wells, the floors which appeared to be soft drink advertising sheet metal, were rusted beyond repair. The true extent of the PO honesty was he never mentioned anything, especially the tubes of bathroom chalking pumped into the totally rusted out chassis rails in the cockpit area. The wool carpeting was totally glued in place as with the lining in the bottom of the boot, therefore my friends never had a chance of making a useful and successful examination.

So after a lengthy chat with two of my close Healey buddies in Winnipeg I elected to buy a new chassis and soldier on. The chassis was shipped from Kilmartin's in Australia to my door for approximately \$900 Canadian which included the shipping and all fees – approximately \$2200 C less then bringing in a more inferior chassis from “Europe”. The Kilmartin chassis has gusseted inner sills, a welded internal webbing in the centre of the chassis rails, and an adjustable shock tower plate to allow for camber adjustments, superior features.
