1953 BN1 (Healey 100) restoration project – present state

Ed Driver

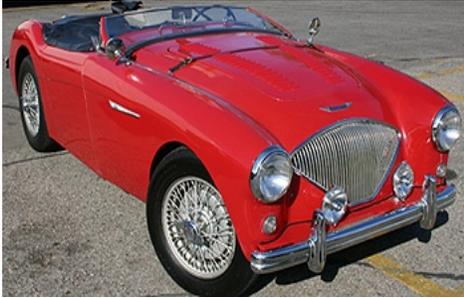
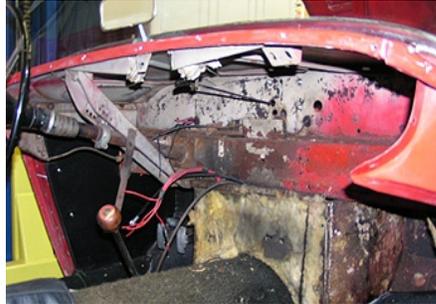
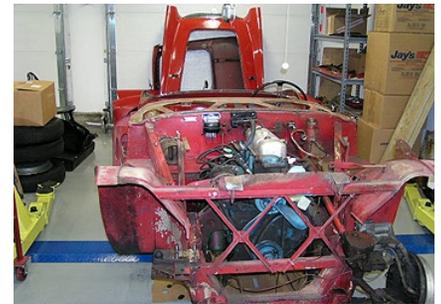
Two friends, one who had restored two Healey 100's, and the president of the Pittsburgh area Austin Healey Club, viewed the car for me. They found a few minor problems and identified a major one, a severely damaged lower front cross member. This was not an issue at that time. A year and a half later the issues began to appear as I started to disassemble the 100. There was further excitement after I had the tub media blasted. RUST! It is a truism which I had known for a long time but decided to buck the current – never buy a car east of the Mississippi. The East is known as the rust belt of LBCs in the US
